Manhole Inspection Summary

Manhole # S290__022MH

Insp Date: **4/13/09 3:07 PM**

Location Address: **1111 W WEST ST**

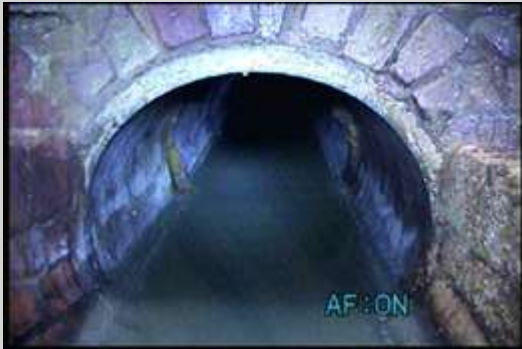
12 O'Clock Outflow

18 in. Circular Gravity Sewer
Pipe Out @ 12 O'Clock

Pipe Height: **18** (in.) Rod and Bar (Angled)
Pipe Material: **Clay** ☐ Pipe Lined
Invert Depth: **12.52** (ft.) Flow Characteristics: **Slow**
Deposits: ☒ None ☐ Mud ☐ Sludge ☐ Debris ☐ Grease
Silt Depth: **0** (in.) Deposits Extent:
Infiltration: **None** Pipe Seal Cond: **Sound**

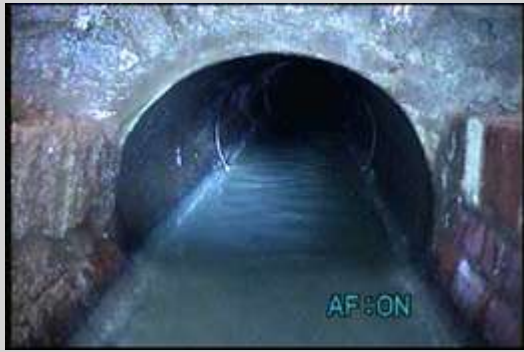
6 O'Clock Inflow

18 in. Circular Gravity Sewer

Pipe In @ 6 O'Clock

Pipe Height: **18** (in.) Rod and Bar (Angled)

Pipe Material: **Clay** ☐ Pipe Lined

Infiltration: **None** Pipe Seal Cond: **Sound**
